The Devil is in the Detail

Was MV Dali hacked?

Loss of propulsion and near grounding of Viking Sky, Hustadvika, Norway 23 March 2019

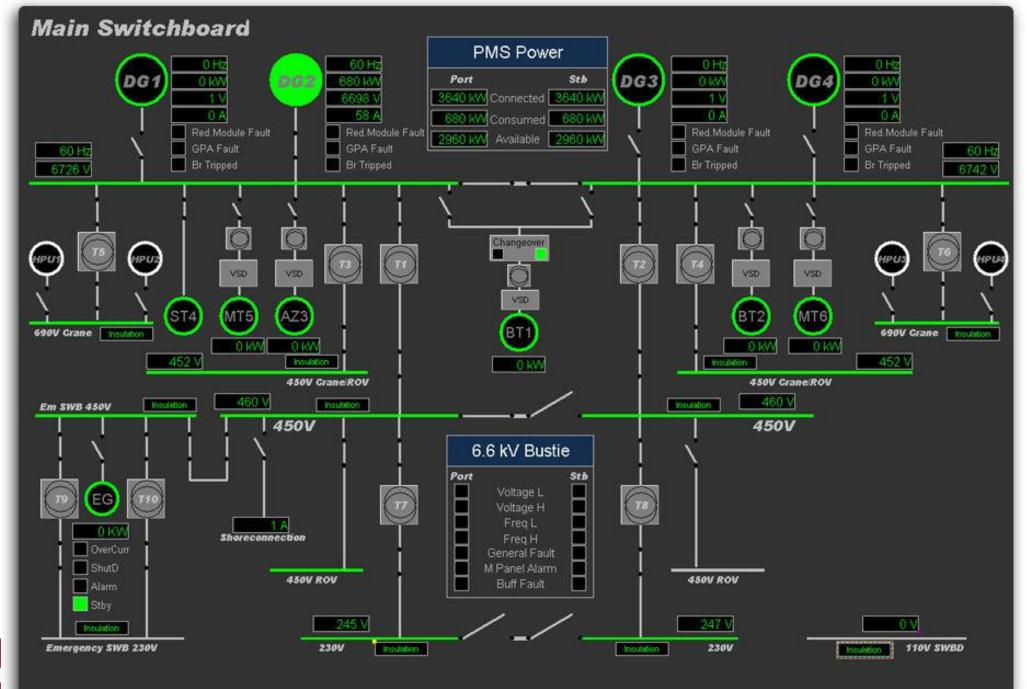
Ideal Recovery

Generator trips - blackout Emergency generator starts Standby generator starts Ancillaries start Main engine can be used

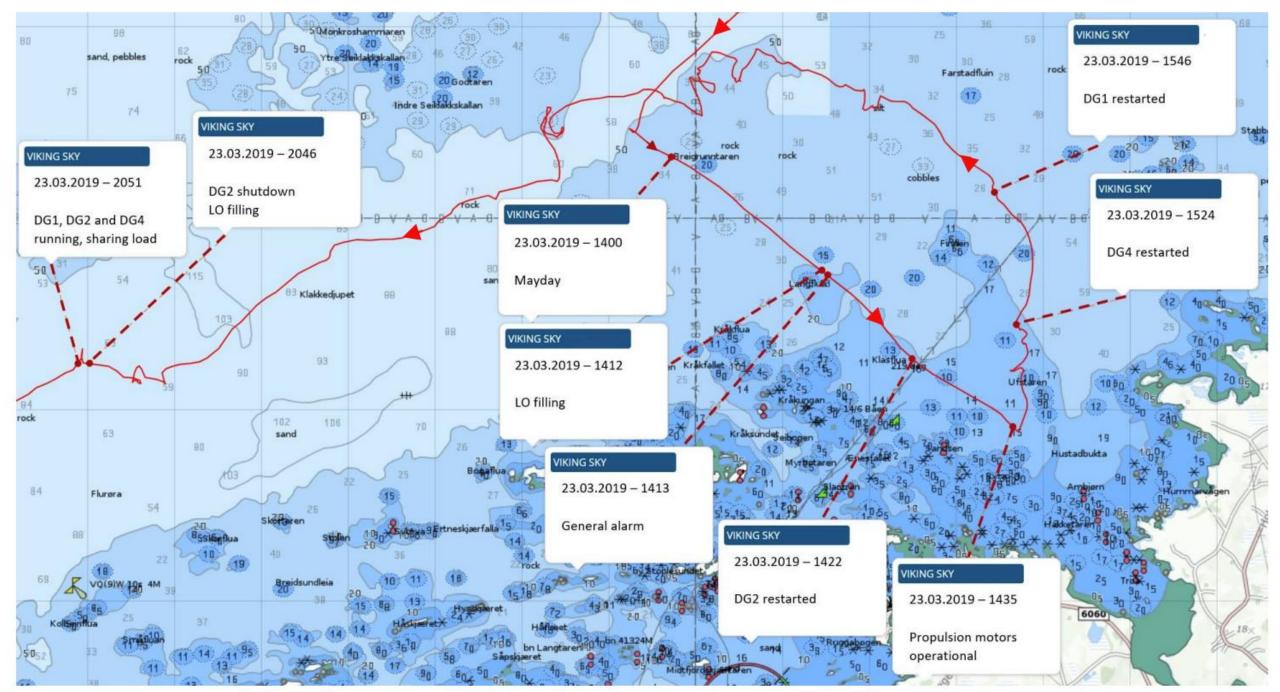
Figure 15: Events during restoration of power. Source: The Norwegian Coastal Administration AIS / NSIA

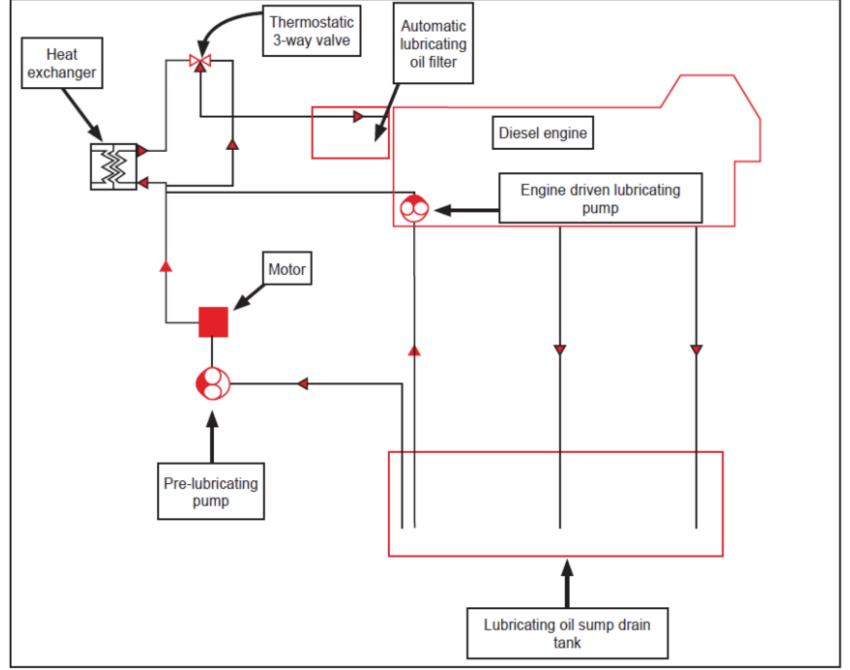
Figure 30: Schematic drawing of the diesel generator lubricating oil system. Illustration: NSIA

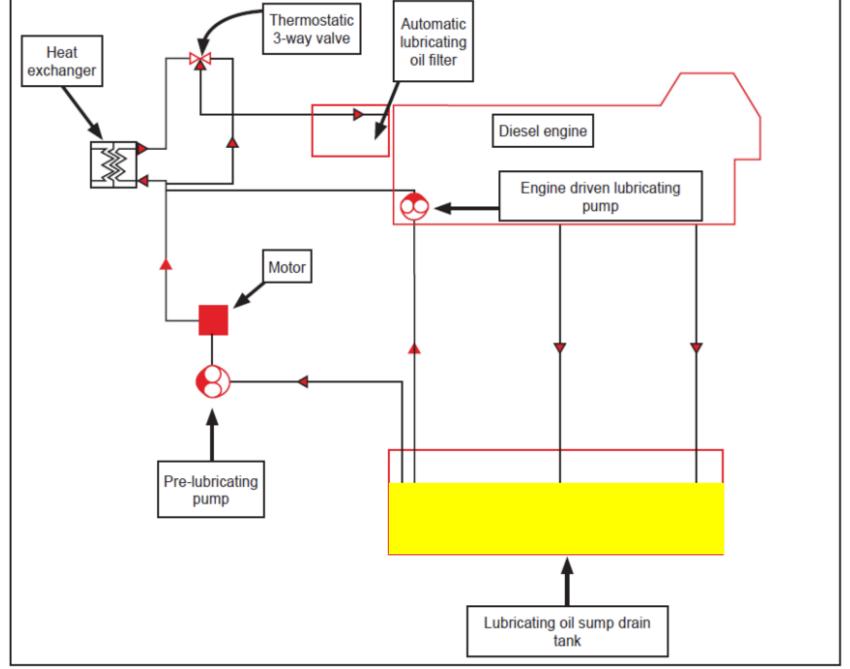
Figure 30: Schematic drawing of the diesel generator lubricating oil system. Illustration: NSIA

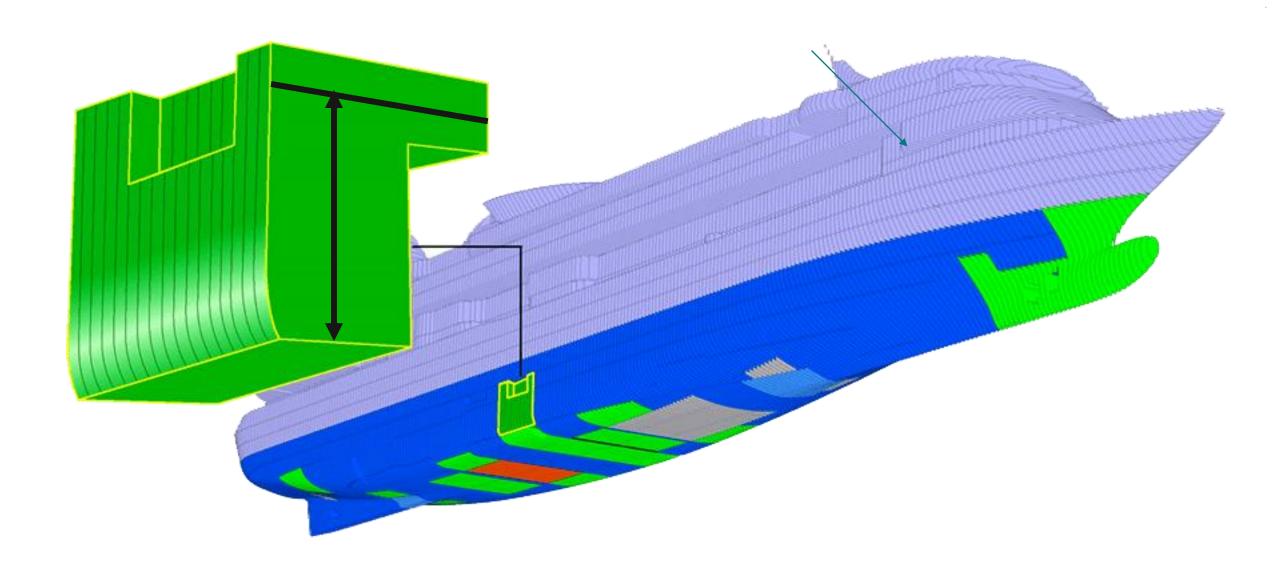
The following operator inputs were required for remote monitoring of the sump tanks:

- Offset of the sensor tube (mm)
- Density of the oil (g/cm3)
- Alarm levels (m3)

These values could be adjusted in the IAS by any of the engineers, with **no means of identifying what had been changed, by whom, when or why**.

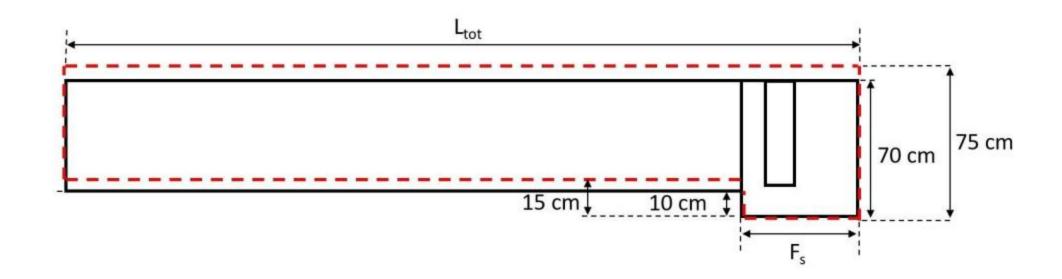
The investigation has identified that there was an error in the 3D model geometry. This caused an error in the calculations.

The volume calculation will return a value 568 litres less than the actual oil volume.

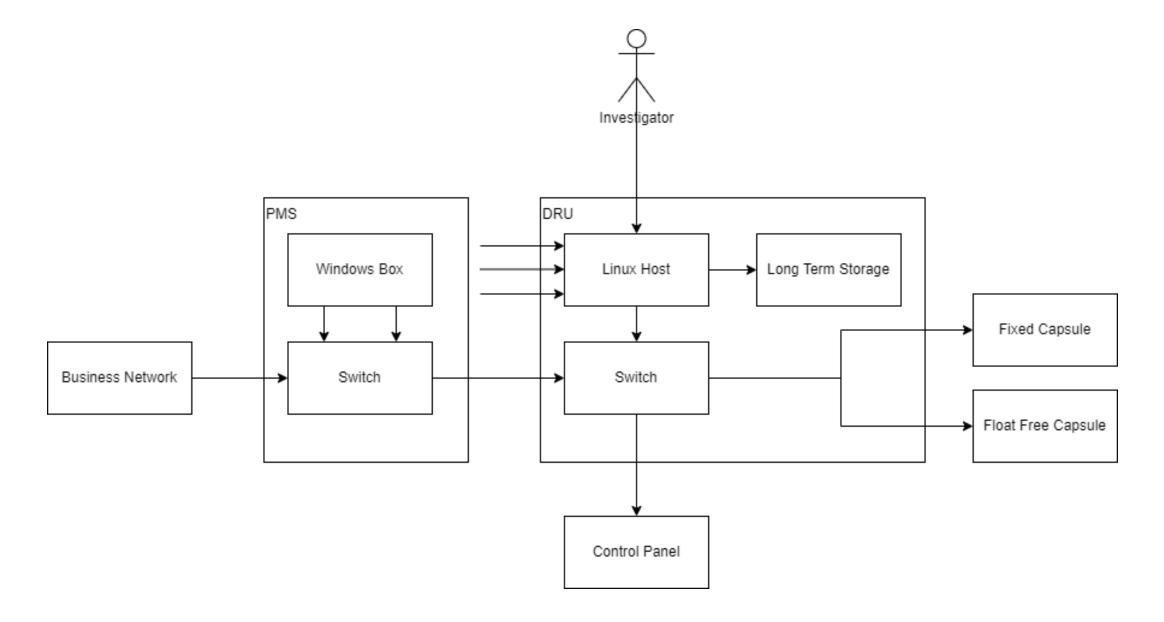
IP	At MAC Address	Count	Len	MAC Vendor / Hostname
10.0.6.1	9c:dc:71:c1:59:9b	13	780	Hewlett Packard Enterprise
10.0.0.2	00:d0:1d:06:63:03	1	60	FURUNO ELECTRIC CO., LTD.
10.0.0.100	00:e0:27:26:0b:31	1	60	DUX, INC.
10.0.0.101	90:2e:16:d1:c3:d6	1	60	LCFC(HeFei) Electronics Technology co., ltd
10.0.0.120	00:d0:1d:11:98:62	2	120	FURUNO ELECTRIC CO., LTD.
10.0.0.130	00:d0:1d:11:98:f3	1	60	FURUNO ELECTRIC CO., LTD.
10.0.0.140	00:02:9f:04:95:3c	1	60	L-3 Communication Aviation Recorders
10.0.0.150	00:06:cb:1b:01:d0	1	60	Jotron Electronics A/S
10.0.6.23	00:15:5d:e1:c3:04	3	180	Microsoft Corporation

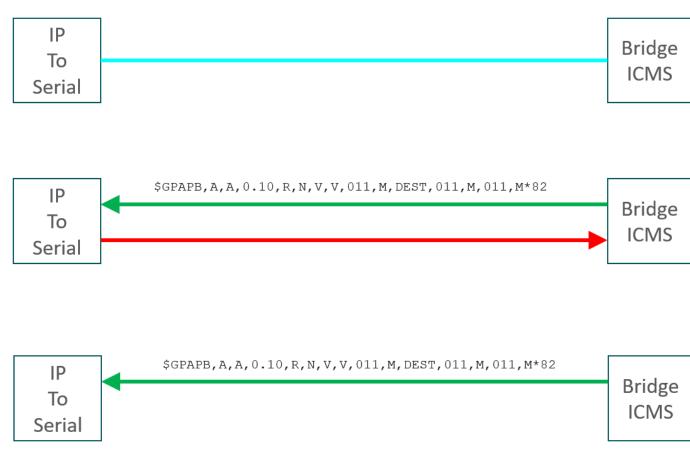
Transmit only works!

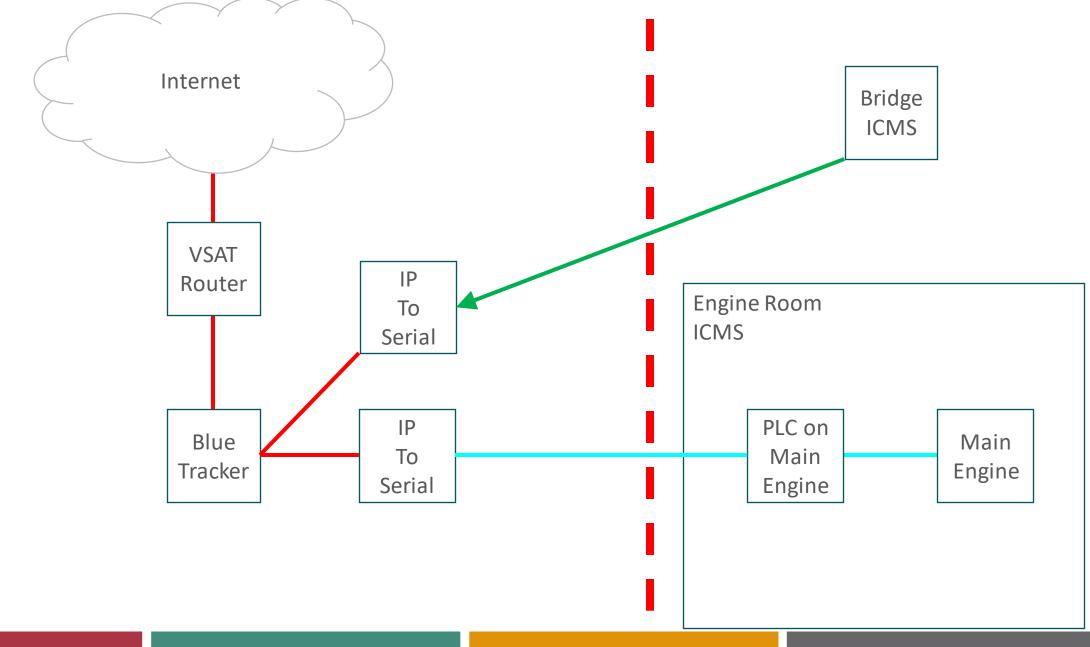
Modbus – request/reply Needs transmit/receive

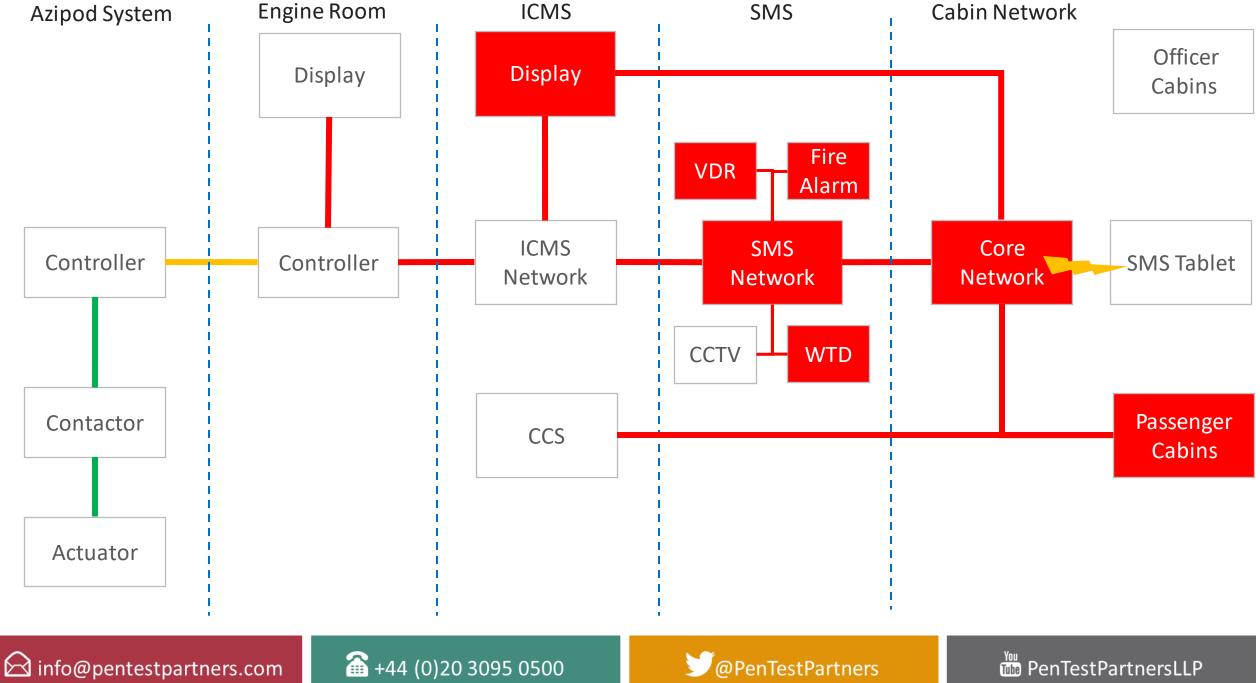
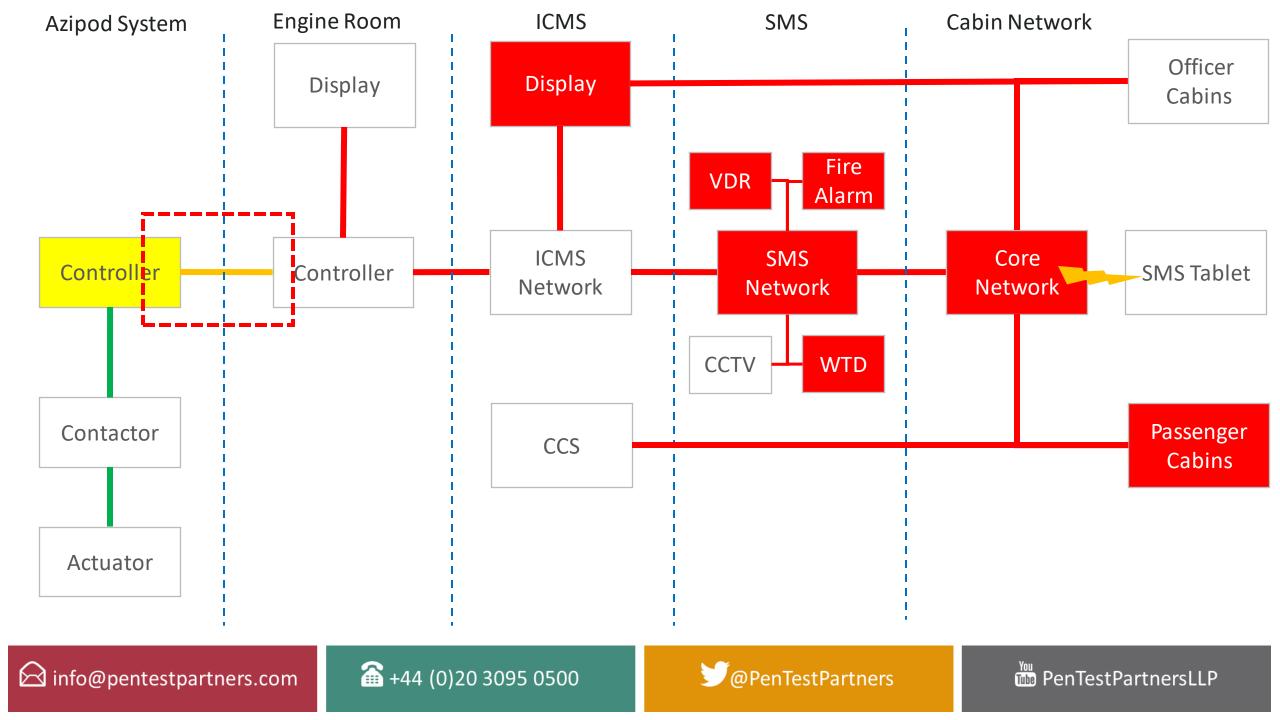
Azipods

"The azipods are connected to the ICMS by serial and for monitoring only"

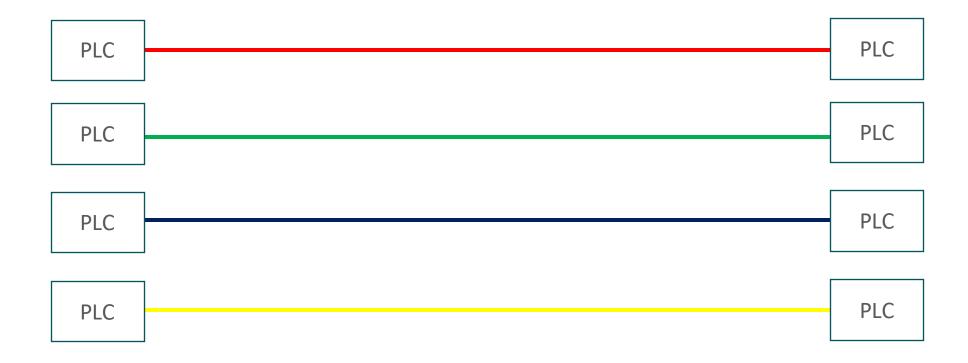
Discrete Serial

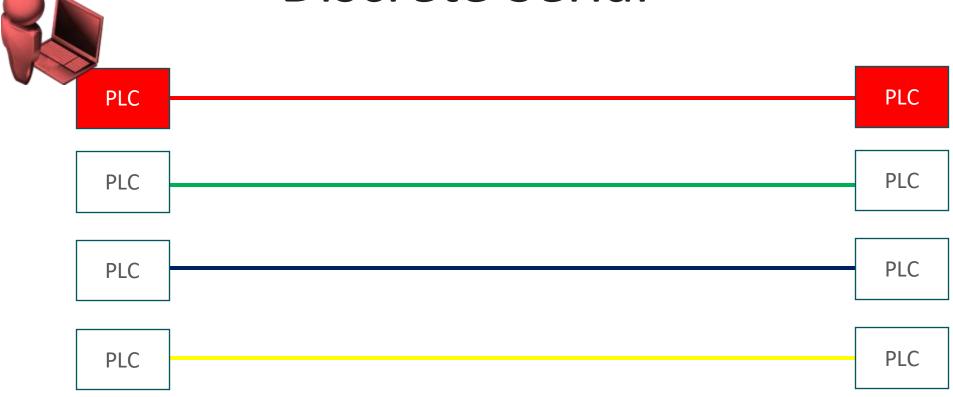
Discrete Serial
